Title Vibration monitoring of Rugeley chimney

Client Bierrum International

Location Rugeley, near Birmingham, UK

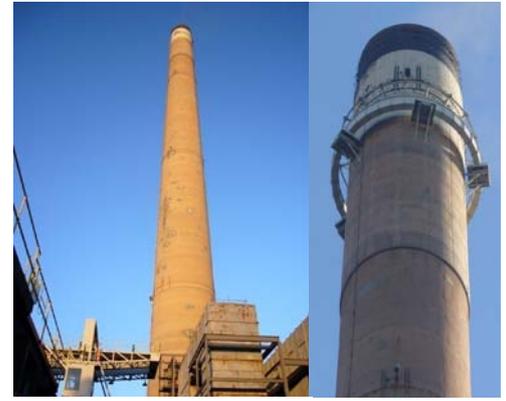
Figure 1: without TMD

Figure 2: with TMD

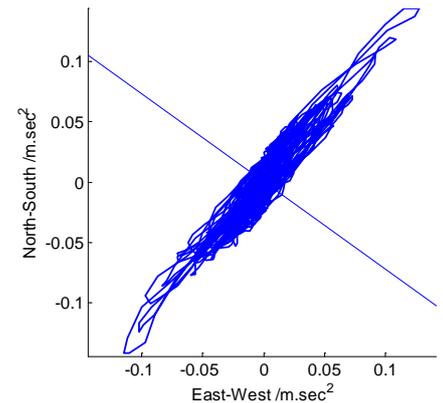
Figure 3: Typical cross-wind response due to vortex shedding

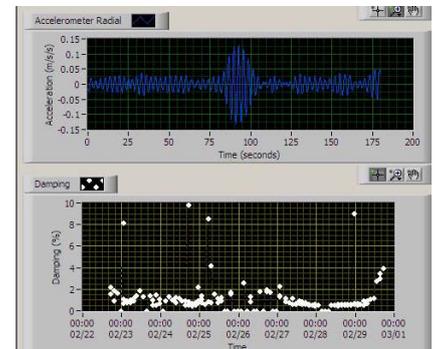
Figure 4: Response and damping reported by the system in February 2007

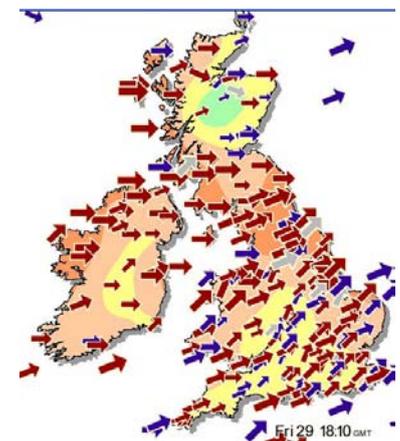
Figure 5: Corresponding wind conditions
